Summary of Monitoring of Drainage System Excavations at 46CB41, November 29 and 30, 1996

JENKINS HOUSE
46CB41
DRAINAGE SYSTEM

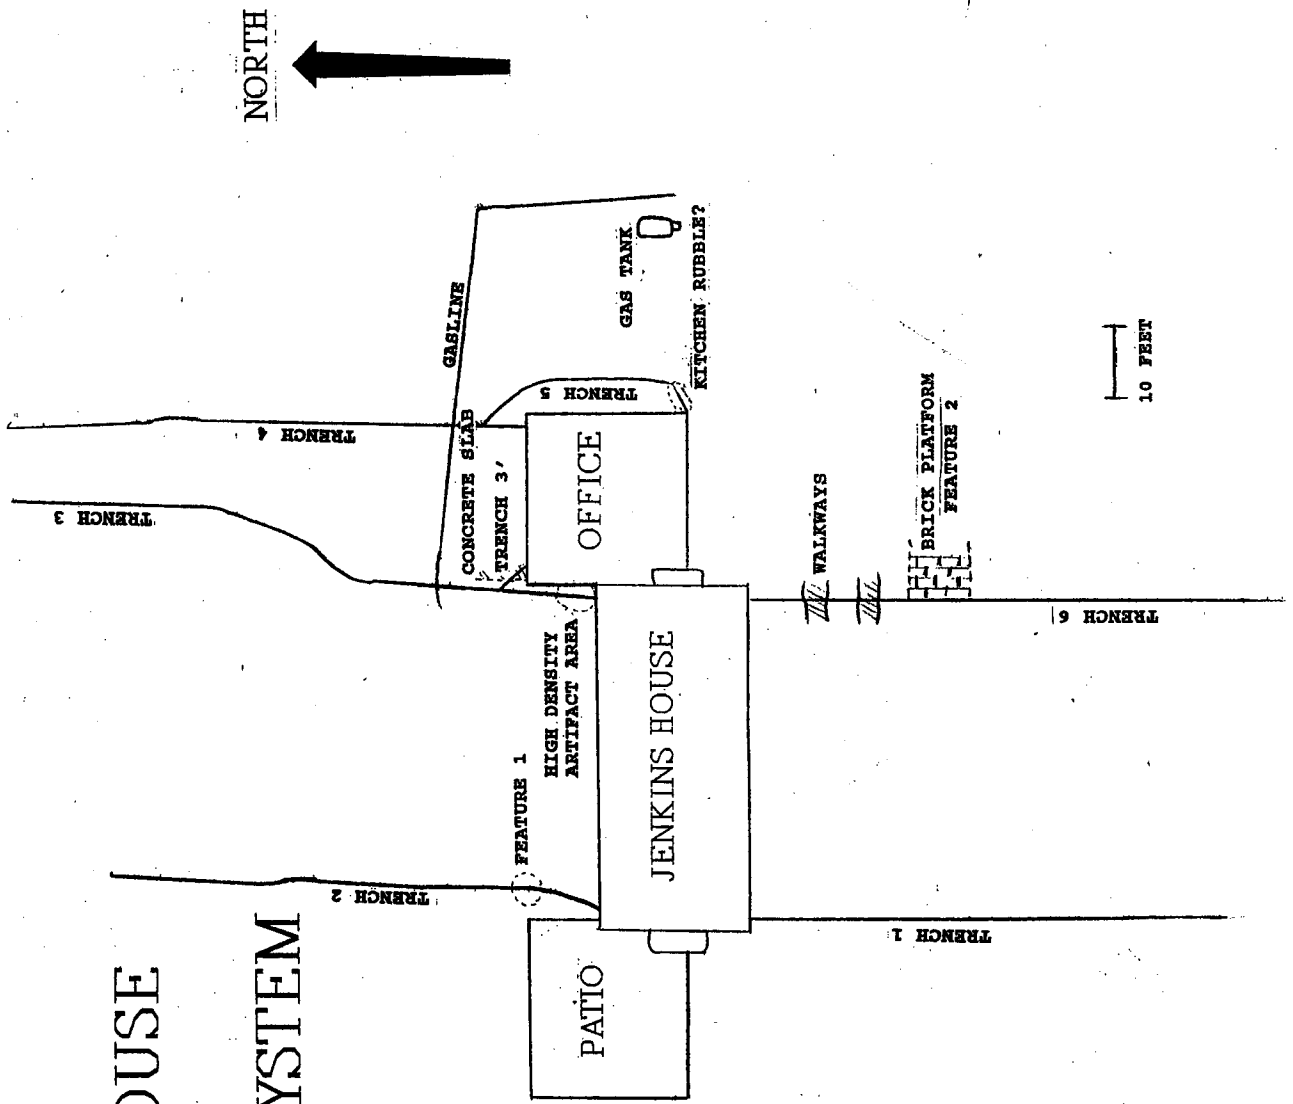
I drew a map of the site area and designated all the trenches and features. This map is to scale and was developed using both a measuring tape and pacing (see attached).

1. Map showing features, excavated trenches, existing gasline, etc.
2. Copy of 1906 photograph taken facing northeast. Photograph shows two structures about 20 feet east of the Jenkins House.
